Re: June 2012 Monthly Progress Report
Administrative Settlement Agreement and Order on Consent for Removal Action
U.S. EPA Region 10 Docket No. CERCLA 10-2009-0255
Gasco Sediments Site within the Portland Harbor Superfund Site

Attachment A Monthly Visual Monitoring Report for Pilot Cap Vicinity

Visual Observations Log Form

Monitoring Period: Monthly (Year 6)—June 2012

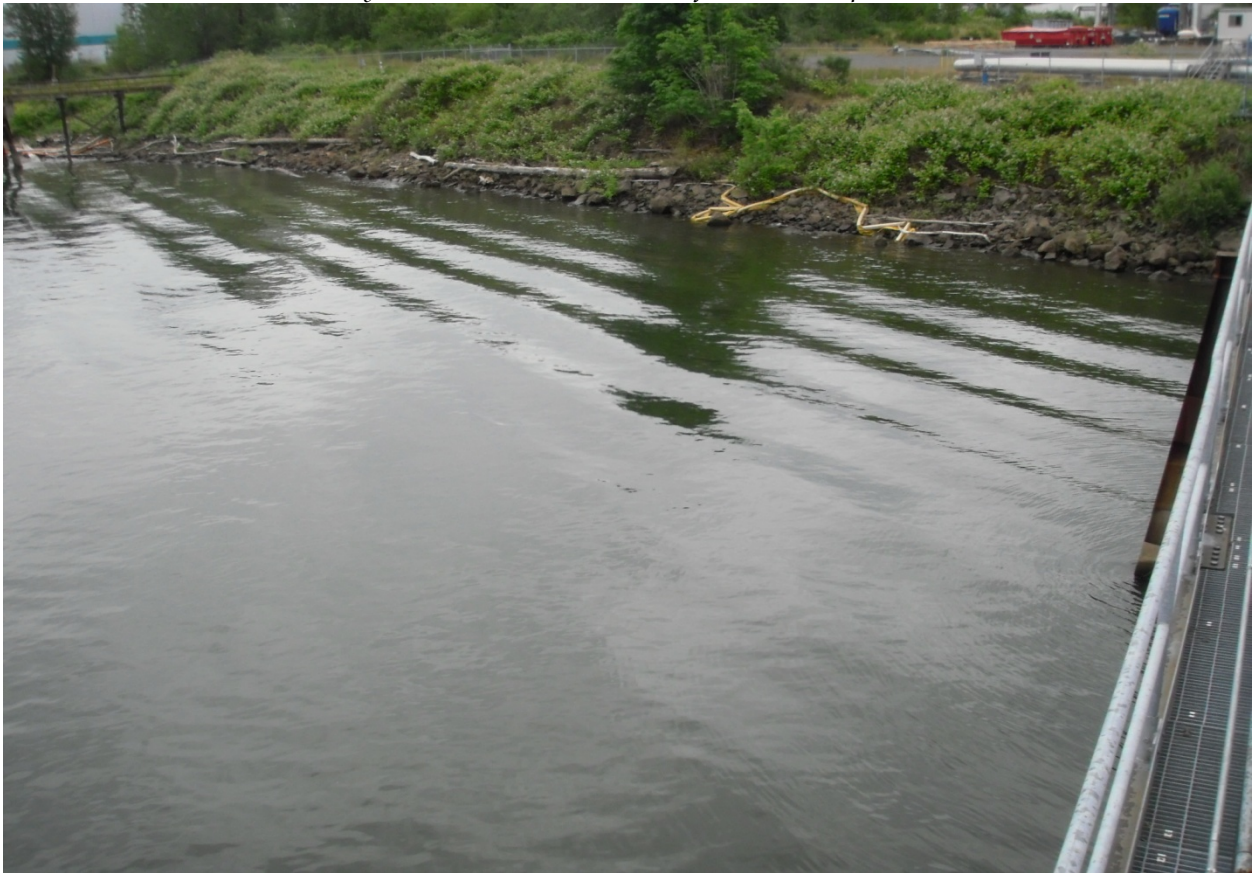
Observations of Erosion/Deposition: No erosion/deposition is evident along the shoreline. The shoreward extent of the cap was not visible due to high river water elevation; and the extents of the organoclay mat material were also submerged. (Photo 1).

Photo 1 — *River level currently elevated above the extent of sediment cap (6/22/12):*

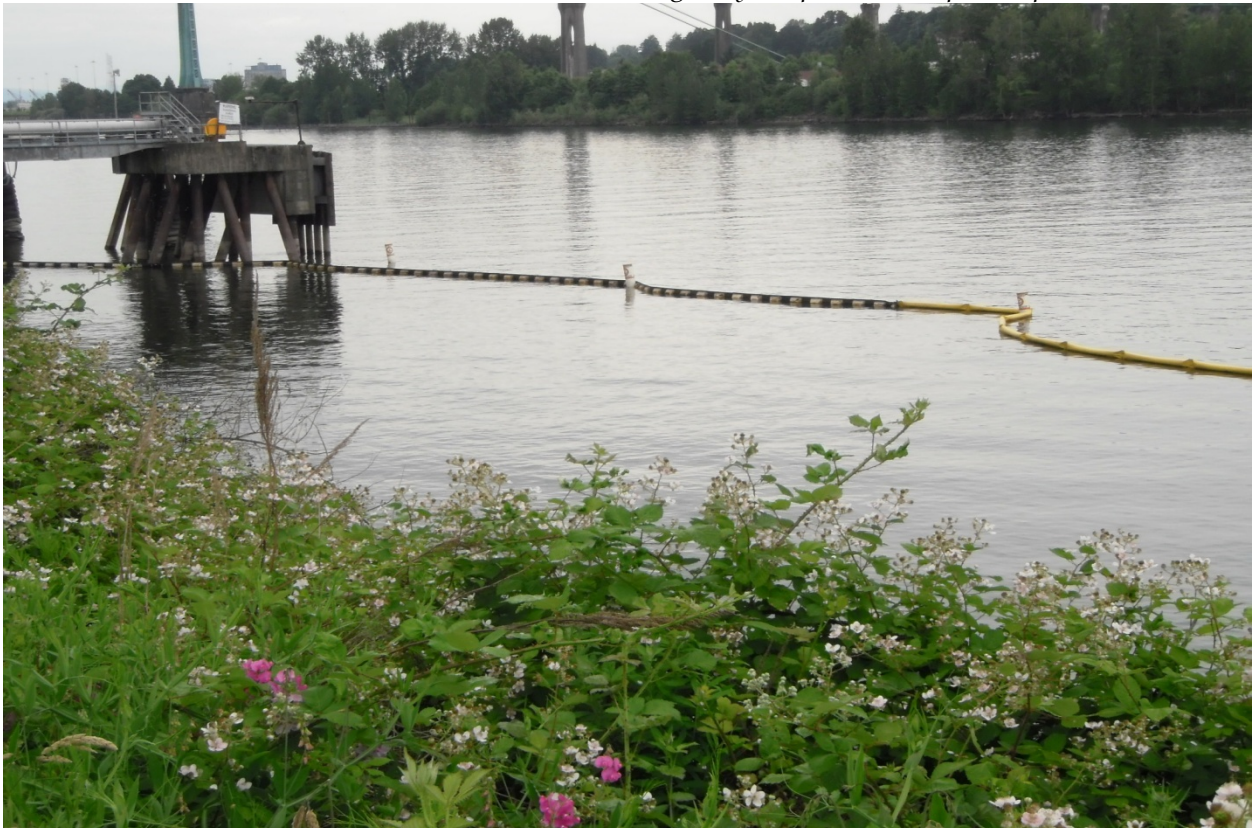
Observations of Long-term Controls (i.e., oil booms, organo-clay mat, etc.) During the observation, the Fuel and Marine Marketing (FAMM) containment boom was placed across the cap area, between the upriver corner of the ship dock and the wooden dolphin (near the upriver extent of the site and near the Siltronic Corporation outfall). Buoys that identify the cap area to mariners are in place as installed. The position of the FAMM oil boom, warning buoys, and a general overview of the site shoreline is shown in Photo 2.

Photo 2 — *FAMM oil boom shown and mariner warning buoys in place across pilot cap area. 6/22/12):*

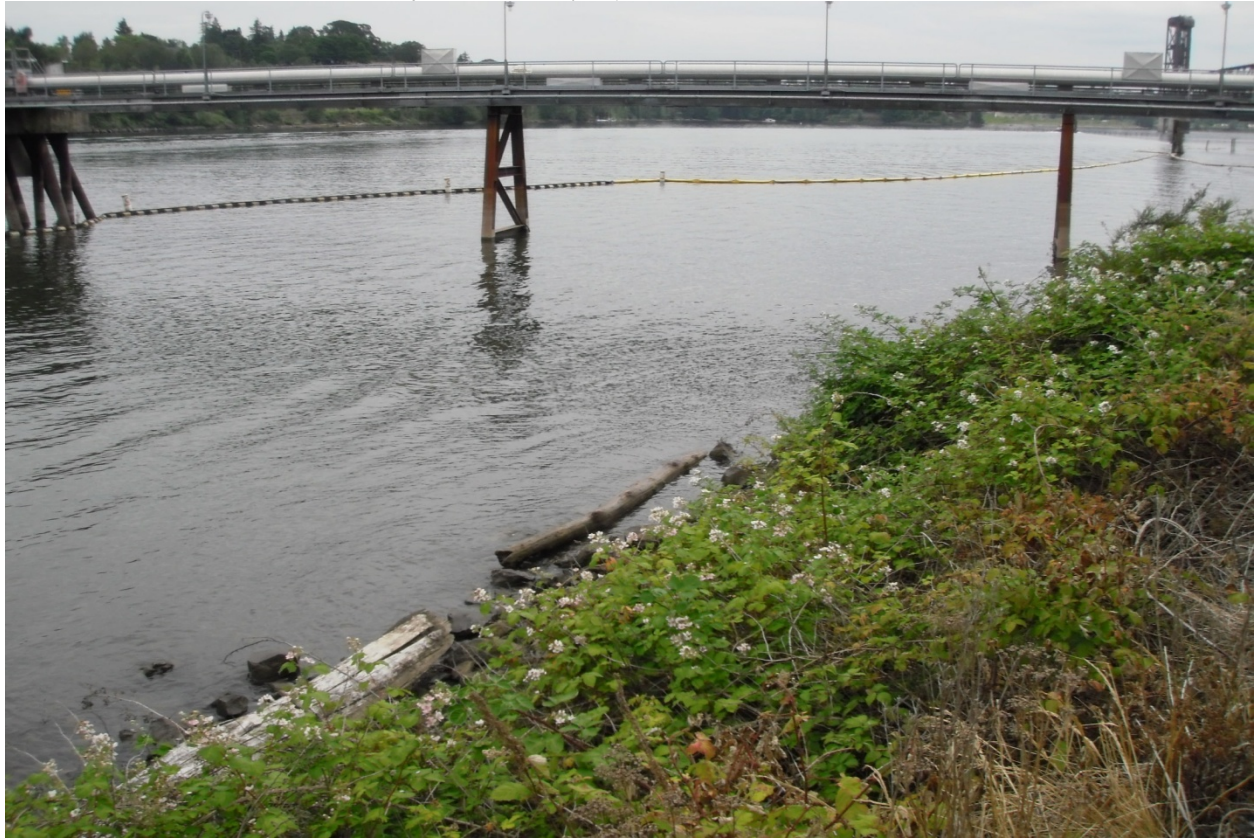
Other Comments: No sheen is evident in or around the cap area. Photo 3 shows the water surface and shoreline immediately downriver of the sediment cap.

Photo 3 — *Conditions immediately downriver of cap area (6/22/12):*
